AB Fence Tech Sheet

In-House Full-Scale System Testing On AB Fence Panel

Round 1 with Single Point Load Transfer Configuration

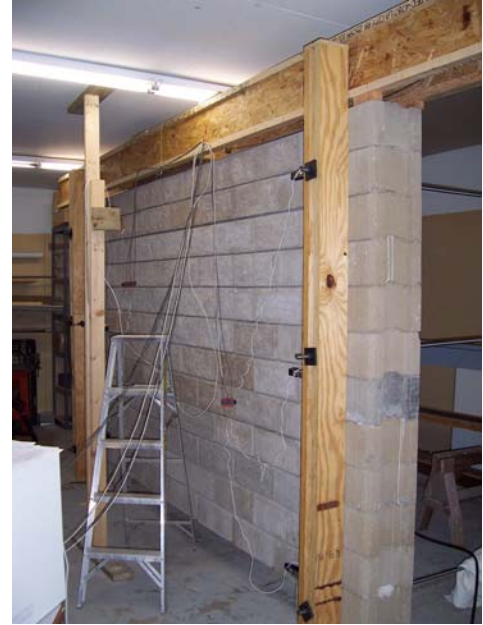
This tech sheet summarizes the results for the full-scale panel tests performed on the Allan Block fence panel using 2 two-course traditional bond beams for lateral support. All tests were performed in the Allan Block lab using Allan Block equipment and personnel. These tests were conducted as an extension of the fence testing performed at the University of Calgary in 2003. However, this testing includes four different height configurations ranging from 4ft to 8ft (1.2 – 2.4m) or 6 to 12 courses. The wind loads were simulated using a hydraulic ram with a worst-case configuration of full load development at the mid-span of the panel. A single vertical spreader bar transferred the applied force to the two bond beams and the bottom bond beam free spanned from post to post. This setup was chosen because it forces the load transfer to the bond beams in a more direct fashion, which mimics the current design methodology.

The principal objectives of these tests were to determine the interaction between the rigid bond beams and the dry stacked units and how this interaction affects the forces applied to the supporting posts. The outcome will be a series of reduction values to more accurately design for the applied moment in the structural post. The current design methodology uses wind stagnation pressures provided by the 1997 UBC code. The design methodology only allows the designer to use 100% of the applied wind load divided by the number of transverse load carrying members (bond beams) and then transfers 100% to the supporting vertical posts. It has been observed in the Calgary testing that a dissipation of forces occurs during testing. The Allan Block tests had the force applied to the mid-span by use of a hydraulic ram and the received load at the posts were recorded using load cells at three points on each post. By simply comparing the applied force to the received, a percentage of loss can be determined. Also a sensitive deflection device was used to accurately measure the repeated deflections and rebounds the panel and bond beam endured during the complete test series.

During the first set of tests at 6-courses tall, the bond beams were very stiff and resisted the applied force with very little deflection. Once the final force representing the 150 mph (241 kph) force was applied, stress cracks appeared in the center of the panel blocks and adjacent to the mid-span. At the end of this test when the load was relaxed the deflection returned to basically zero from a maximum deflection of .51 in (13mm). In all subsequent tests the deflection was recorded to progress evenly as the load increased, with a maximum recorded deflection of 1.575 in (40 mm) in Test Set-Up #4.
